East Sussex
Fire & Rescue Service

Fire Engineering Report

Sheltered Housing Complex East Sussex

Date of Fire: 24 April 2013

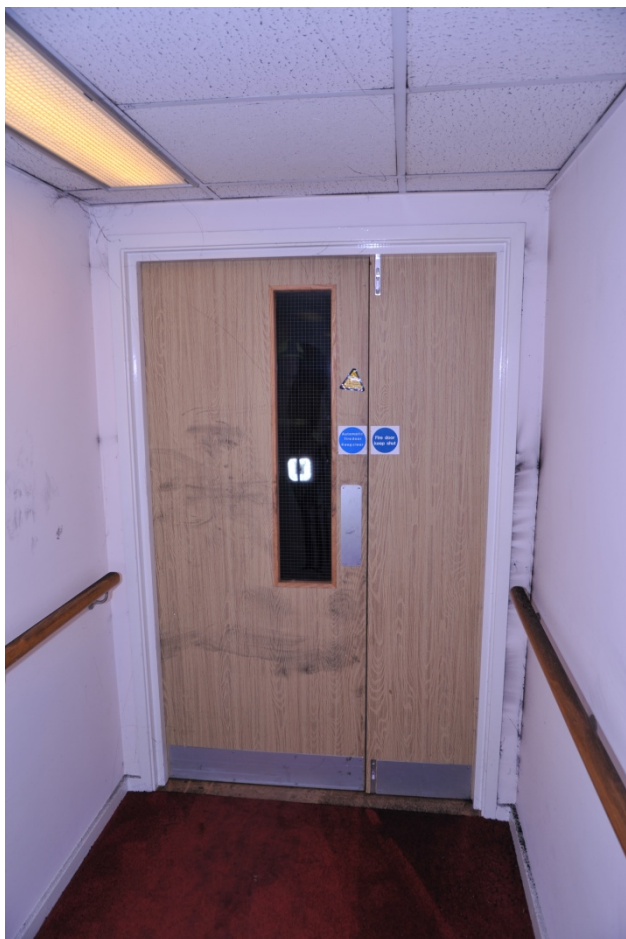
Photo 1 – Corridor immediately outside the fire compartment

- 4.3 On approach to the fire affected area, there was very little indication of a fire having taken place:-
- some slight smoke staining from fire gases being forced through the doorframe by over-pressure;

- some sooty deposits on the carpet and handrails in the immediate area due to the doors being opened for firefighting;
 - a few smudges made by the fire crews (*see Photo 1*).

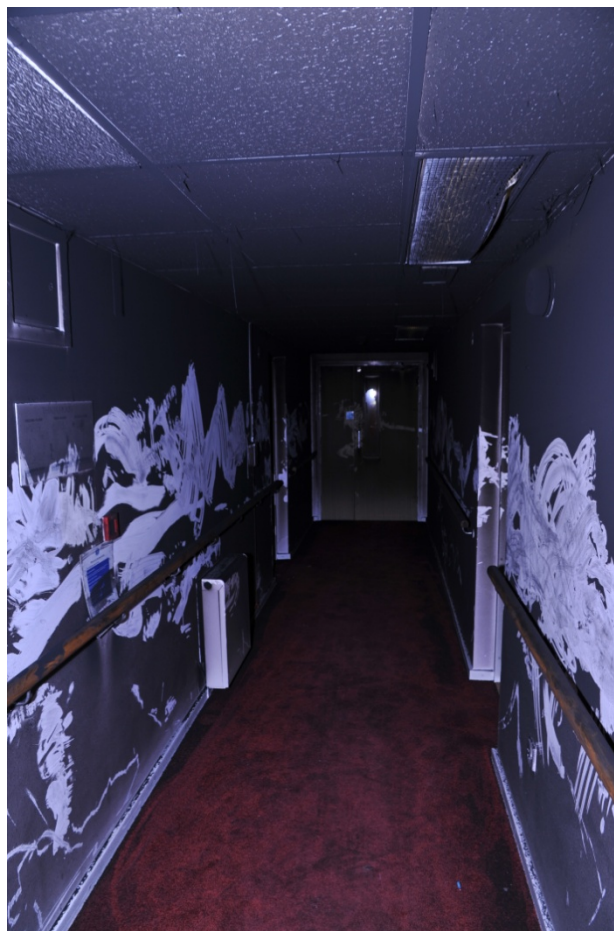
Photo 2 – Inside the fire compartment

- 4.4 However, on entering the fire compartment there was evidence of significant smoke staining and heavy sooty/carbonaceous deposits on all surfaces (*see photos 2&3*). The area of burning on the floor was relatively small with a light fitting directly above, recessed into the false ceiling (*see photo 4*).

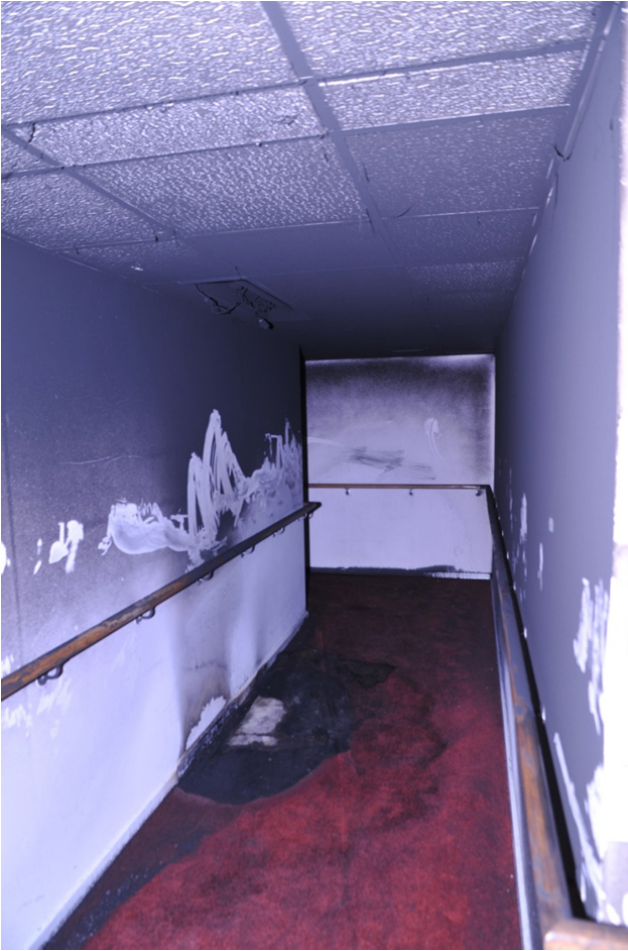
Photo 3 – Seat of fire and light fitting above

- 4.5 There appeared to be only 2 possibilities for the item first ignited – either the carpet or the light fitting. There were no accidental sources of ignition in the vicinity that could account for the carpet being the item first ignited, and the use of an accelerant on the carpet was discounted by a hydrocarbon dog. Therefore, the most likely item first ignited was the light fitting.

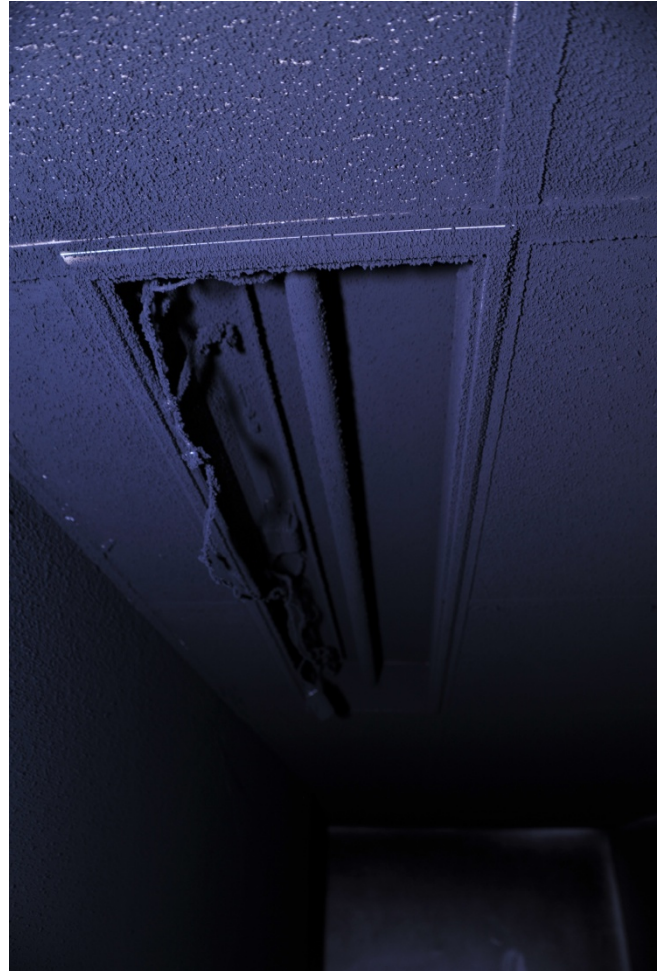
Photo 4 – Light fitting above seat of fire showing heavy sooty deposits

- 4.7 Although deliberate ignition of the light fitting could not be ruled out, the most likely cause of ignition appeared to be a fault in the light fitting igniting the diffuser, which eventually fell out of the light and onto the carpet below, burning away completely (apart from the metal clips) and leaving only the carpet burning. This would explain why the crews reported that the fire was easy to extinguish. However, this still did not explain why this relatively small fire had produced such heavy sooting and so quickly. We took away a large sample of un-burnt carpet and 2 identical diffusers from neighbouring lights with a view to re-creating the sequence of events.

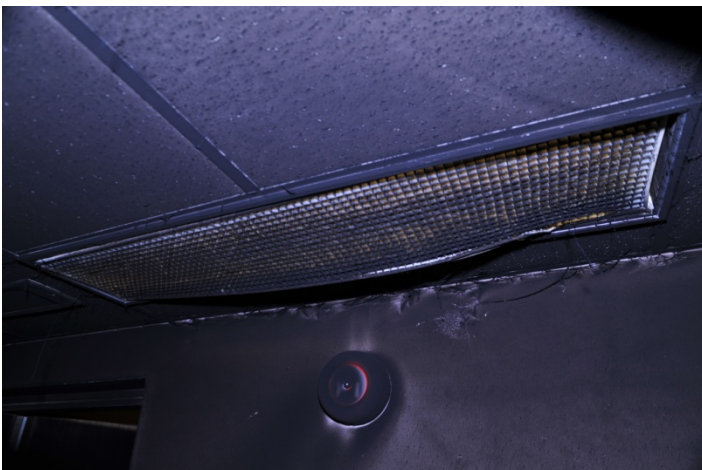
Photo 5 – Neighbouring light fitting showing diffuser in place

- 4.6 There was no diffuser on the light fitting or any indication of debris in the seat of fire except 3 or 4 small metal clips. However, examination of a lighting diffuser from a neighbouring light showed that it was held in place by 6 metal clips similar to those found in the seat of fire (*see photo 5*).

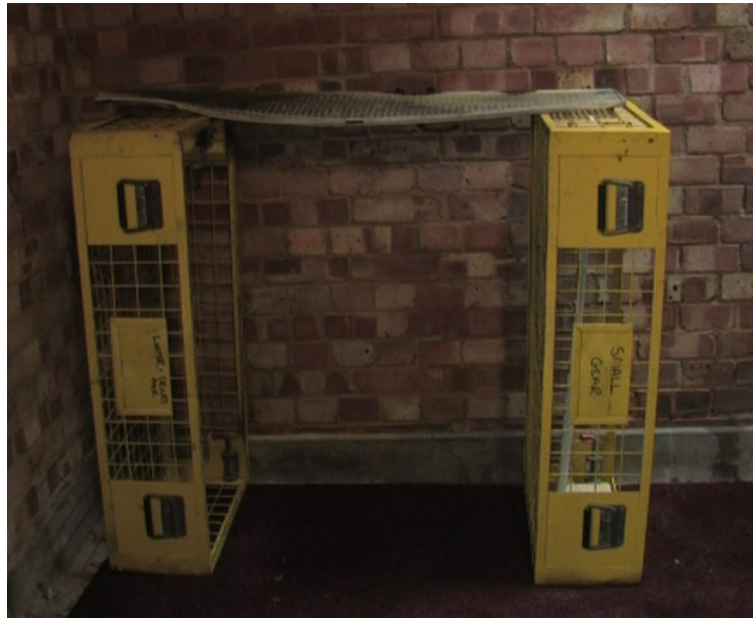
Photo 7 – Test Burn 1
Test set-up

4.16 A diffuser was balanced across 2 crates approximately 1m high above a section of carpet from the premises (see *photo 7*). The diffuser ignited readily using a blowtorch and started giving off thick black smoke almost immediately. It then started to drop flaming droplets of molten plastic within 20 secs which ignited the carpet below (see *photo 8*). The area quickly became uncomfortable to be in due

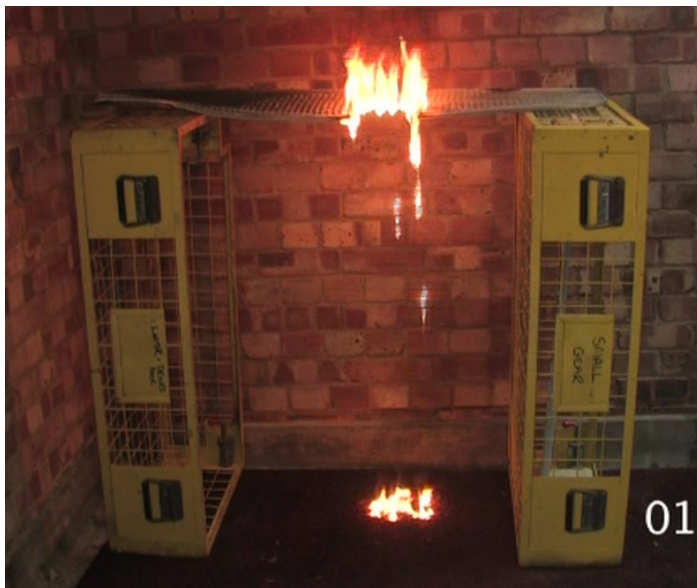
Photo 8 – Test Burn 1
Flaming molten droplets

to the smoke produced and the camera was left recording while we moved outside. After 4 mins 10 secs, the diffuser had melted sufficiently to drop out of the light fitting to the floor, where it continued to burn easily. However, there was minimal fire spread, confirming that the carpet made little contribution to fire growth. After approximately 6 mins the fire was extinguished as the drill tower had not been prepared for a live burn of any significance. Due to the early intervention, there were remnants of unburnt/partially burnt diffuser in the debris (*see photo 9*).

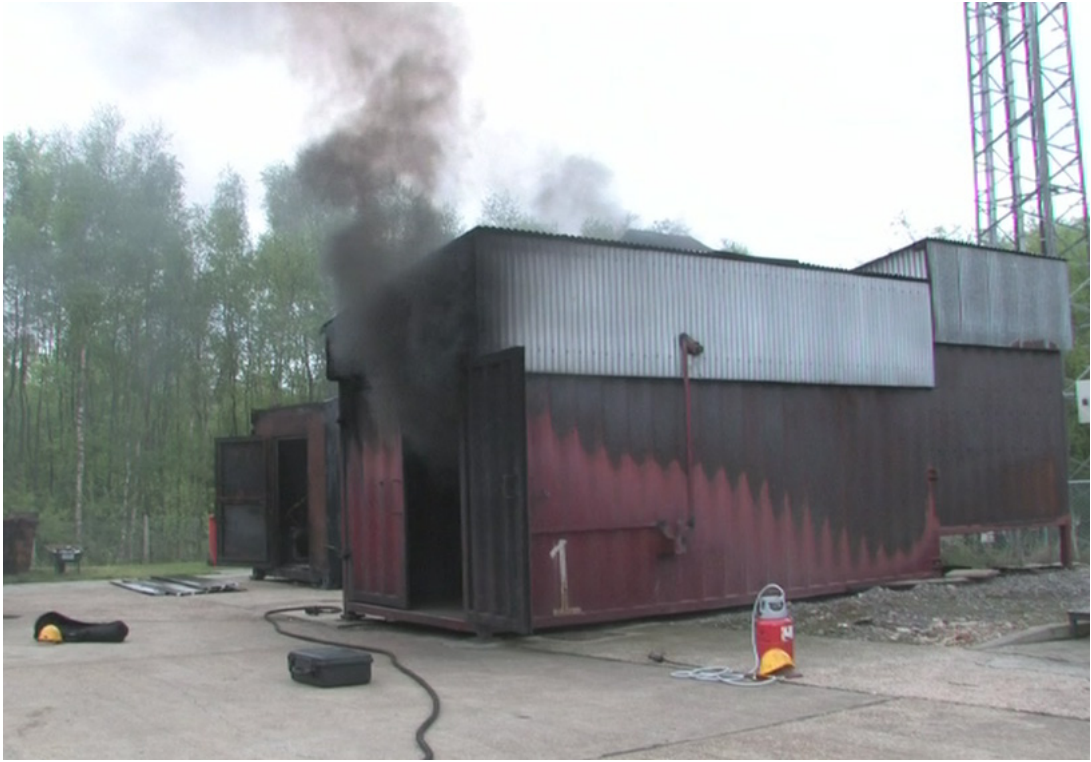
Photo 10 – Test Burn 2
Hot Fire Unit

- 4.17 The second burn was set up in a metal shipping container, simulating a section of corridor (*see photo 10*). The doors were open at the end furthest from the test area. The diffuser was hung between 2 chains at approximately 2.1m high and another section of carpet was placed underneath. Again it ignited readily, despite only using a match. The video camera placed inside the unit, but within 2 mins of the diffuser being ignited, the conditions were too uncomfortable to stay due to the airborne particles being generated by the fire. The camera was moved outside the unit for the remainder of the test.

- 4.18 Similar to the first test burn, flaming droplets started falling at approximately 17 secs, with the diffuser falling to the floor after about 4 min 30 sec. This footage shows the large quantity and poor quality of smoke very well (*see photo 10*), and supports the evidence from the incident. The fire was eventually extinguished approximately 15 mins after ignition. As reported by the crews at the incident, the fire was easily extinguished, using a short spray of water from a hosereel.

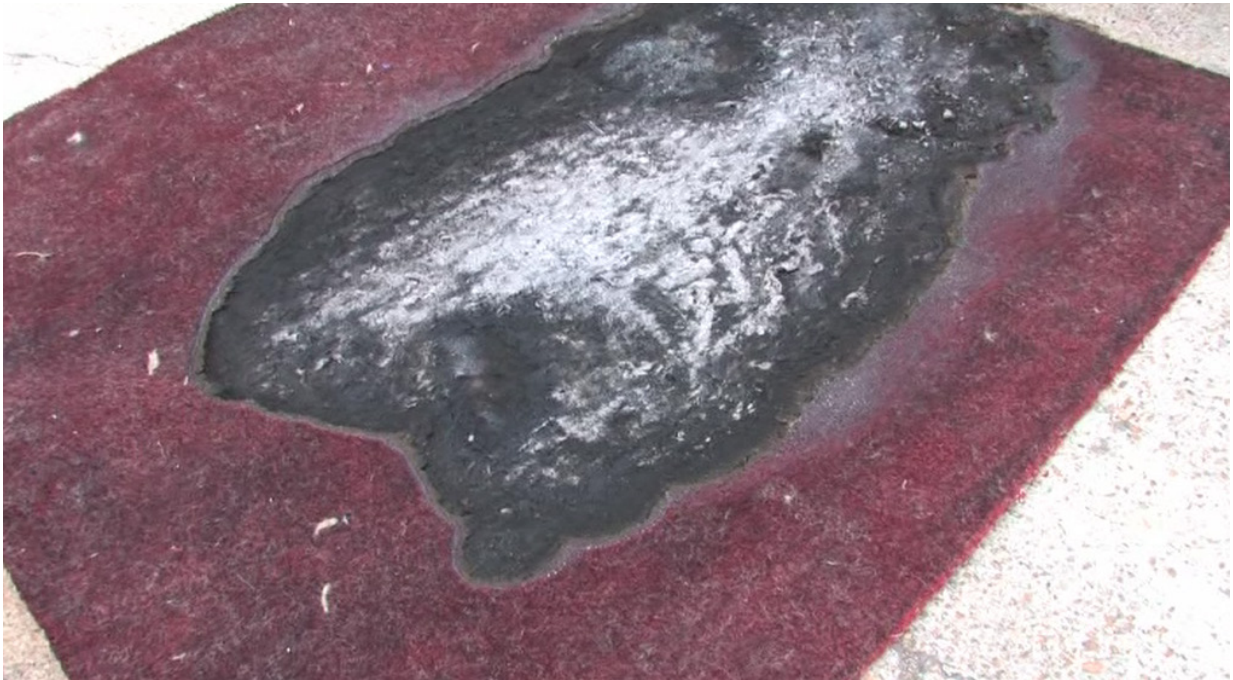
Photo 11 – Test Burn 2
Test specimen

- 4.19 The carpet looked very similar to that from the incident, containing little debris except the metal clips from the edge of the diffuser (*see photo 11*).
